Proofing of Fenced enclosure behind supermarket a RodeXit Case Study

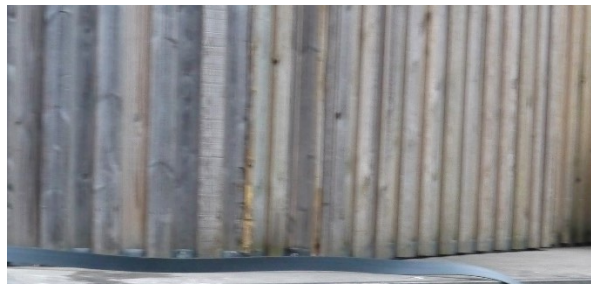
The bottom gap and the side gaps of the fence were proofed with the European equivalent to the RodeXit STRAIGHT proofing strip. Because the proofing strips comes in 27 yd. (25 m) long coils it was possible to proof the bottom gap with only 2 very long pieces without any weak joints:

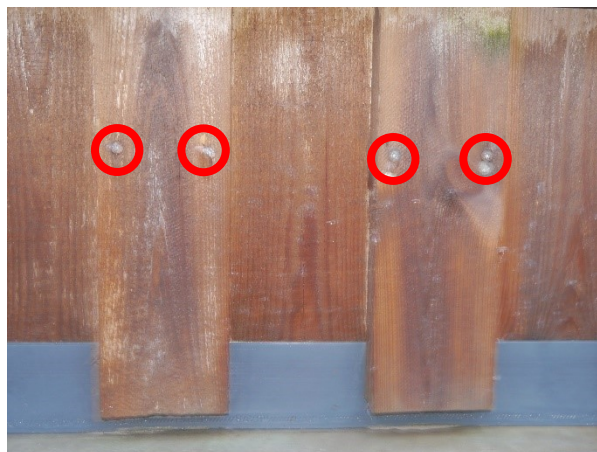
Every second plank was loosened by loosening the lowermost screws, and the proofing strip was tucked up between the planks. Thereafter, and the screws were re-tightened. On this picture the loosened and retightened screws are marked by means of red circles and the positioning of the proofing strip can be seen:

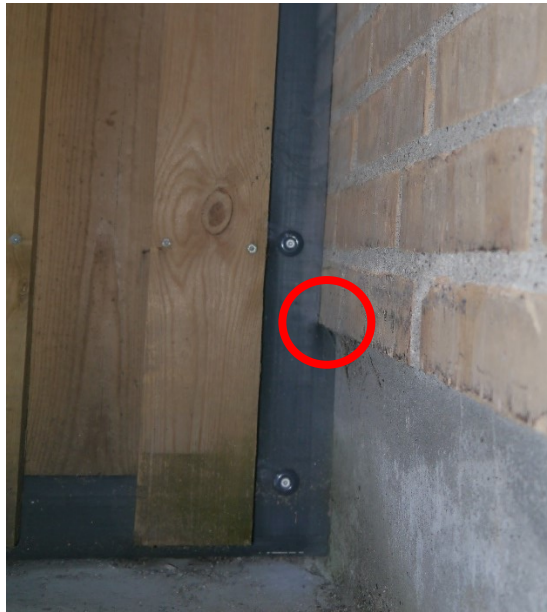
The side gaps were proofed with single vertical proofing strips mounted on the adjacent planks of the fence by means of screws and washers. Each of the pieces of proofing strip was cut by straight tin snips and a Stanley knife in a way, that made it possible to get a tight fit with only a single piece in spite of the fact, that the lower part of the side gap was 1 in. (2.5 cm) wide, while the upper part was only ½ in. (1.2 cm). The tricky indentation is marked on this picture by means of a red circle:
