# Proofing of Fenced Enclosure Behind Supermarket

## a Case Study

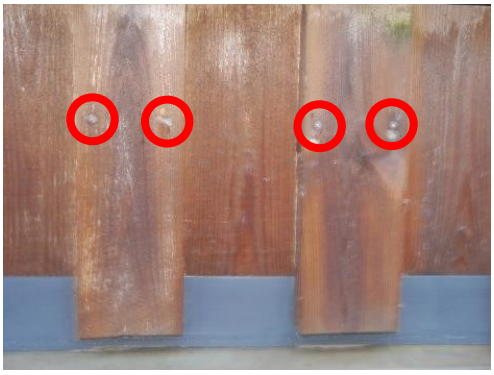
The fence was made of pressure-treated planks. The supermarket building was made of bricks. The gap under the fence was around 1 in. (2.5 cm). So were the side gaps between the fence and the foundation of the supermarket building. The gaps between the fence and the brick wall of the building was only around half of that.

The bottom gap and the side gaps of the fence were proofed with the Danish equivalent to the RodeXit STRAIGHT proofing strip. [1] Because the proofing strips comes in 27 yd. (25 m) long coils it was possible to proof the bottom gap with only 2 very long pieces without any weak joints:

Every second plank was loosened by loosening the lowermost screws, and the proofing strip was tucked up between the planks. Thereafter, and the screws were re-tightened. On this picture the loosened and retightened screws are marked by means of red circles and the positioning of the proofing strip can be seen:
